**to Comments filed by Northern Dynasty Minerals Ltd. in
Docket Number # EPA-HQ-ORD-2012-0276 – “An
Assessment of Potential Mining Impacts on Salmon
Ecosystems of Bristol Bay, Alaska”**

Re: White Paper Series No. 1 – Technical and Regulatory Issues Related to Modern Mining in Alaska

White Paper Series No.1 - Technical and Regulatory Issues Related to Modern Mining in Alaska

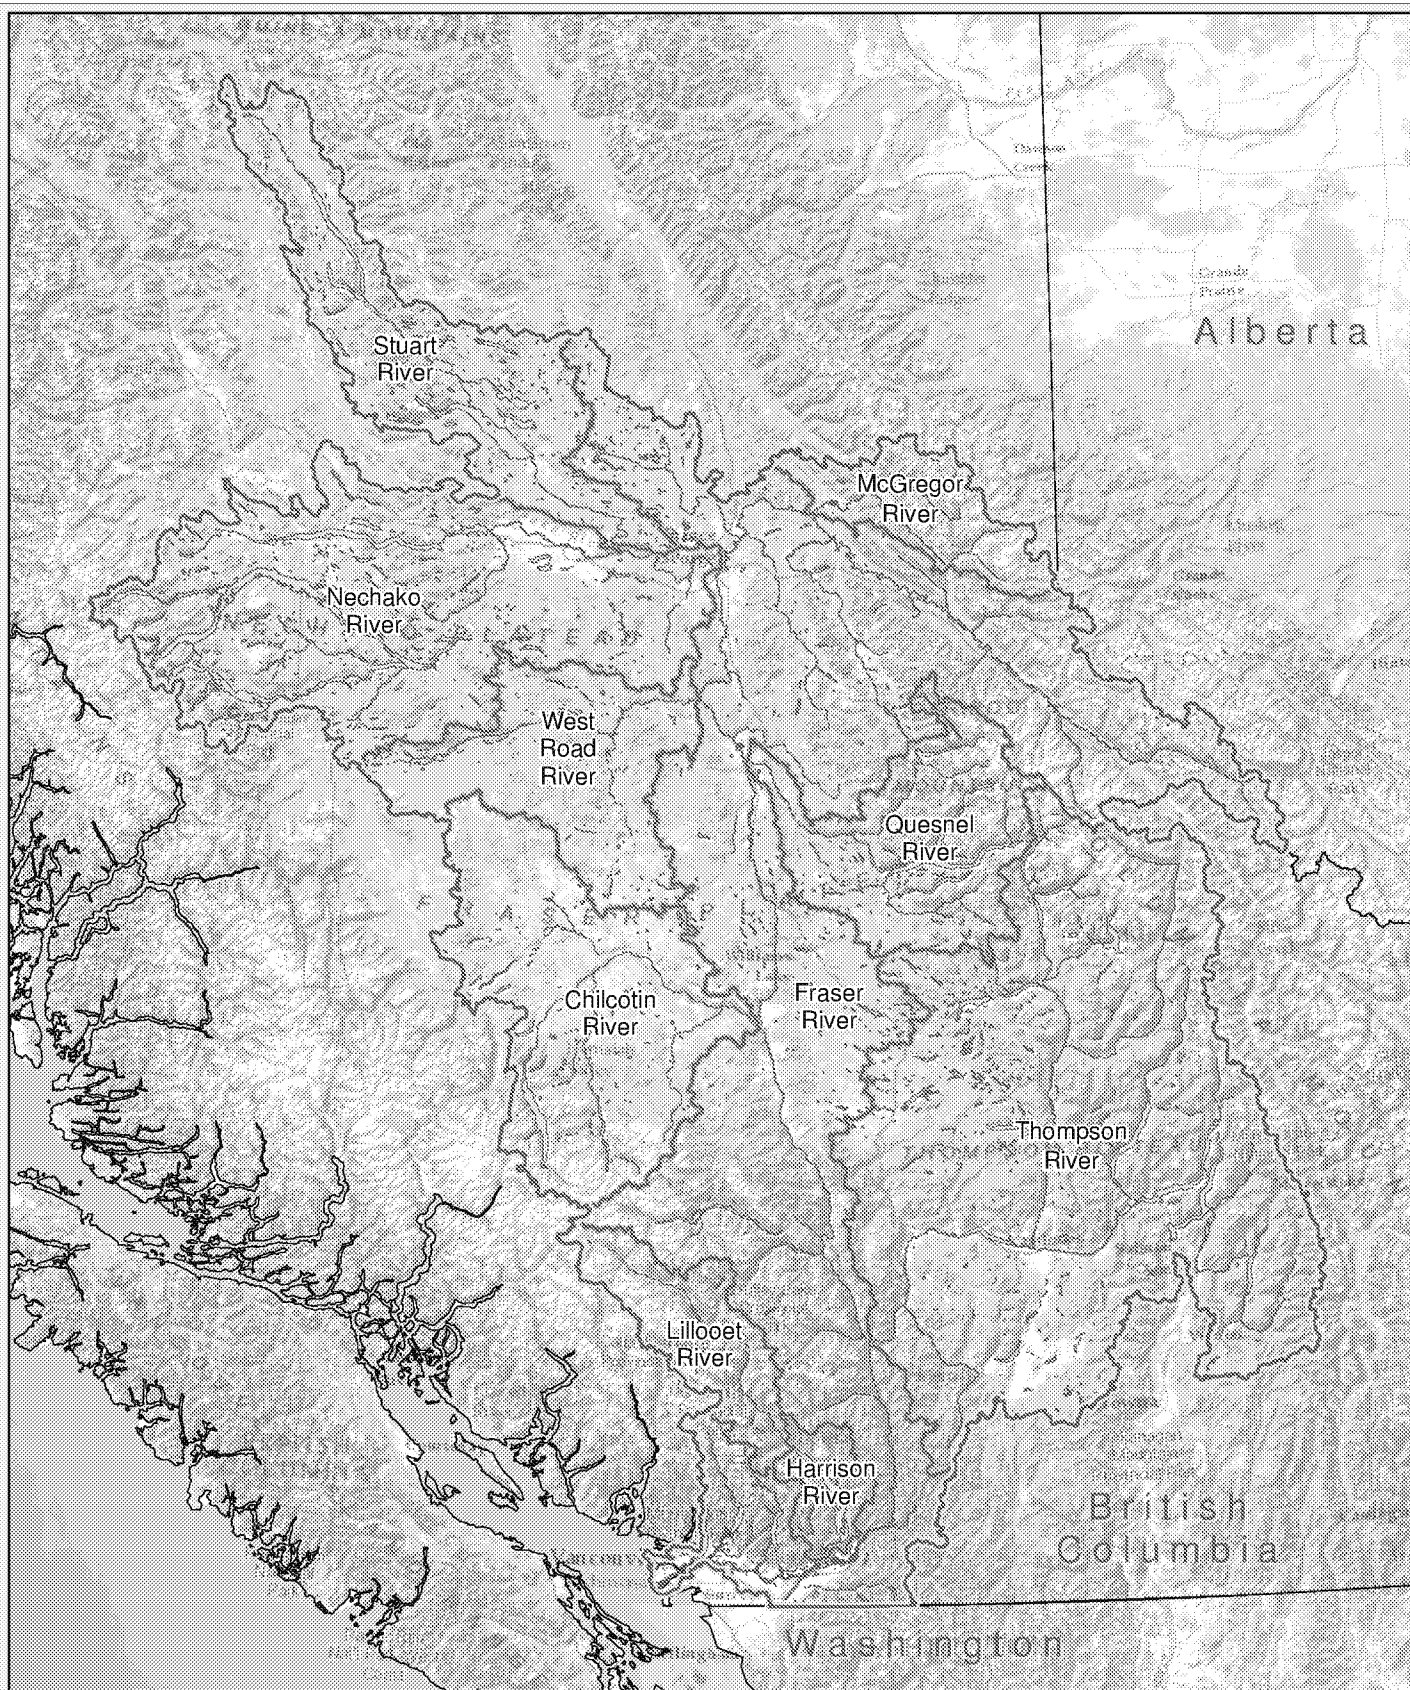
Path: P:\60264275\000-CADD\050 GIS WIP\02_Maps\60264275_Fig_1_Fraser_River_Basin_and_Watersheds_20120711.mxd Date Saved: 7/11/2012 1:02:40 PM User: whitlockk

In 1913 a major rock slide in the Hell's Gate Canyon, 200 km upstream of the Fraser River estuary, significantly impacted the salmon runs trying to reach mid and upper Fraser River streams. The slide was caused by rail road construction activities taking place above the River. This event deposited a large volume of rock in the river creating a velocity barrier that has had a long lasting effect on the Fraser River commercial salmon, in particular the sockeye population. Some researchers suggest that sockeye runs are still recovering from this disaster. While sockeye salmon return to spawn every summer, the population has a dominant year that is repeated every four years.

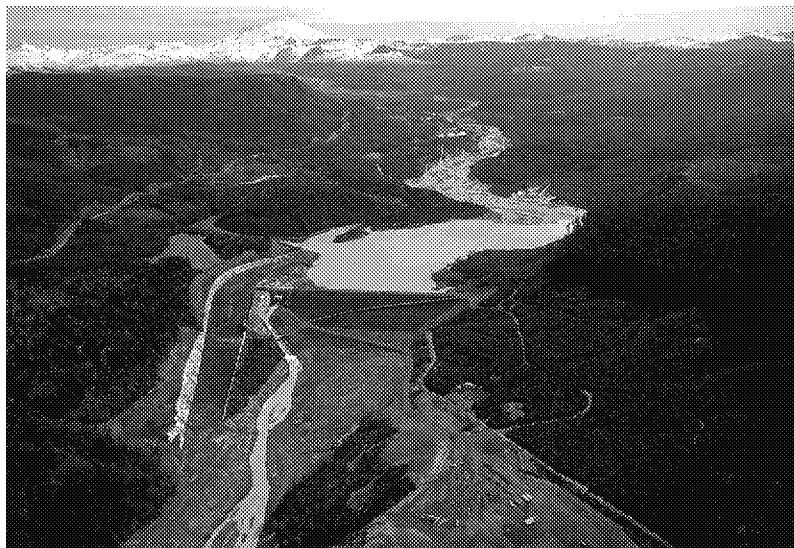
Sediment yields in the Toutle and North Fork Toutle rivers remained above estimated background levels (Swanson and Major 2005) which prompted the United States Army Corps of Engineers (USACE) to construct a large sediment retention structure (SRS) on the North Fork Toutle River at RM 13.2 (USACE 2007). The SRS was built to minimize downstream sediment transport to prevent the disruption of navigable waterways in the Toutle, Cowlitz, and Columbia rivers. The SRS, completed in 1989, is an earthen dam that is 125 feet above the original streambed, 1,800 feet long, and 184 feet high; it included a series of concrete outlet structures to accommodate downstream fish passage. However, in the 25 years since the construction of the SRS, sediment loading upstream and sediment transport over the SRS have resulted in aquatic habitat degradation and both upstream and downstream fish passage concerns (AMEC 2010, Bisson et al. 2005, USACE 2007, USACE 2012). (See Section 6 for further detail.)

Figure 3 – U.S. Army Corps of Engineers sediment retention structure, North Fork Toutle River, Washington, 1990.
